Site Inspection Report

Orderville, Muddy Creek Gemstone Leases: ML 26996, ML 27618, ML 41355, & ML 47588

August 23, 2001

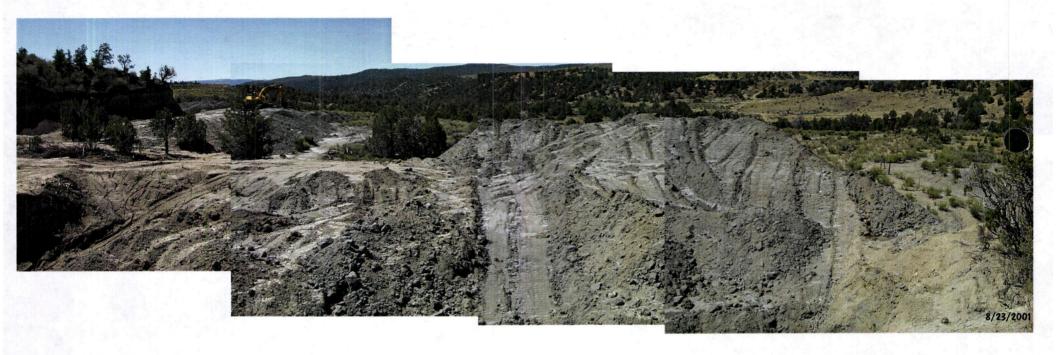
Photograph # /

36 remains at 1.25 acres and the quarry area to the south of the northeast corner, where Mike Caruso is currently mining encompasses 1.00 acre of surface disturbance. Refer to the map labeled ML 26996, of the June 13th, 2000, report and to photographs numbers 1, 2, & 3, of this report.

Looking south from the NE corner of Section 36 onto the quarry, in the very northeast corner of the section, on lease ML 26996. There has been recent excavation by Loy Crapo at this site but the excavation has not significantly increased the size of the disturbed area. The northeast corner of Section 36 is shown in photo # 4 of the June 13 – 14, 2000 site inspection report. The trac-hoe in the background is on the excavation site, presently being worked by Mike Crauso, just south of this site along the east section line. Both sites are shown on the GPS map of the June 13, 2000, report.

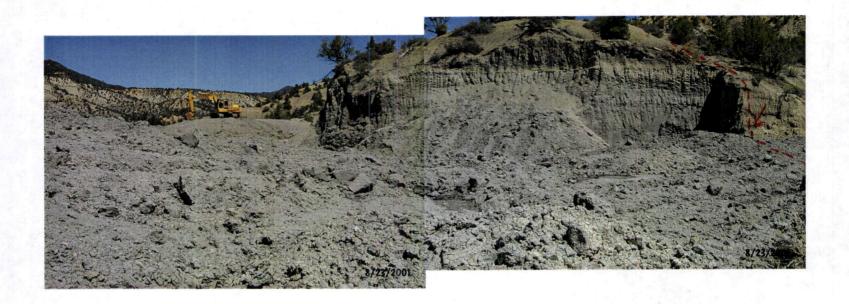
Photograph # 3

Looking northwest onto the site that is currently being excavated by Mike Crauso as shown in the previous photo. This is excavation is located on the east section line of ML 26996, in the NE $\frac{1}{4}$ NE $\frac{1}{4}$ of Seciton 36. He is currently removing material from the small portion of a ridge that extends into the center of the site as shown on the GPS map of the June 13 - 14, 2000 site report. The boundary line of between lease ML 26996 and ML 42355, the Olag Berry lease, is shown by the arrow.

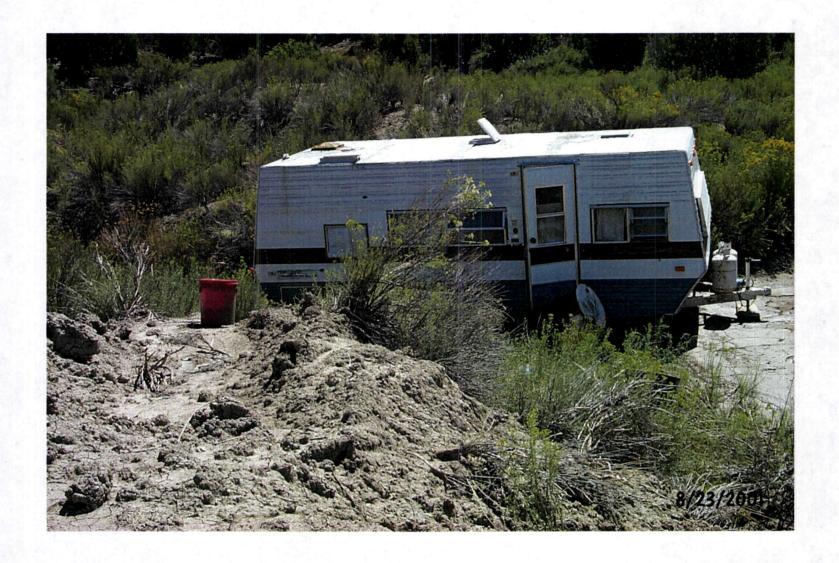
Photograph # 3

A trailer, apparently belonging to Mike Caruso, parked at the excavation site as shown on the previous photograph.

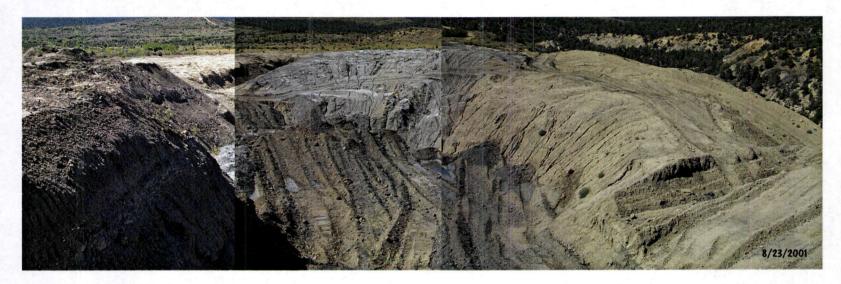
Lease ML 27618, NW¼NW¼, Section 36, T. 40 S., R. 8 W., Lessees: Loy Crapo 50% and Joseph M. (Mike) Crauso 50%. This lease is commonly referred to as the Trail Canyon lease. As of June, 2000, 5.22 acres of land had been disturbed on the leasehold. There appears to have been some recent mining in the area and some of the quarry sites have been backfilled in preparation for seeding this fall. Photograph number 4 of this report shows backfilling of last years quarry site that is depicted in photograph number 8 of the June 13th, 2000 report. Reclamation is jointly shared by Loy Crapo and Mike Crauso, under the \$7,000.00 bond submitted by Loy Crapo. Because the total surface disturbance has not increased noticeably this site was not surveyed. Refer to the GPS survey map, of the June 13th 2000 report, titled ML 27618.

Photograph # $\frac{4}{2}$ Looking south from the center of the mined area on ML 27618, the NW½NW½ of Section 36, from almost the same location as shown in photo # 7 of the June 13 – 14, 2000, surface examination report. The lessee has begun to backfill the pit with excavated material from the north end of this quarry. There is no appreciable difference in the disturbed area at this site.

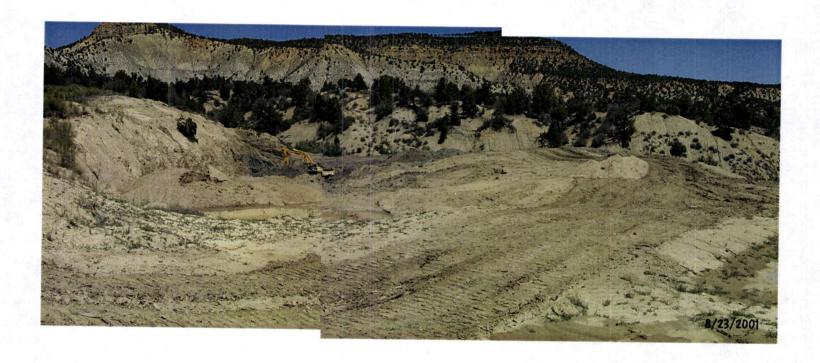
Photograph # 5

Lease ML 41355, W½ of Section 31, T. 40 S., R. 7 W., Lessee: Olga Berry, Operator: Bob Harris. At the time of this inspection Shane Crapo was on site excavating for Bob Harris. The active mine area has been expanded since the June 13, 2000 inspection. The newly mined area encompassed 1.08 acres, 0.20 acres of which was part of last years mined area and 0.25 acres of land that was graded last year was also disturbed by the recent mining activity. See the attached map of the GPS surveyed areas. Total disturbed area is approximately 1.28 acres including the 1.08 acres from this year's activity and the remaining 0.20 acres from last year's activity. Approximately 0.25 acres of previously graded mined lands has also been re-disturbed by the new mining activity leaving approximately 1.60 acres of land that has been graded in preparation for seeding this fall. Photograph number 5 of this report shows surface conditions of the active mine site on ML 41355 at the time of this inspection. Currently the Trust Lands Administration is holding \$2,700.00 for reclamation of surface disturbance.

Looking north onto the excavation currently being conducted by Shane Crapo on the Olga Berry lease ML 41355. A re-contoured area, south of this photo point, is shown in photo # 12 of the June 13-14, 2000 site report. In this year, 2001, the working quarry has been expanded. For a comparison refer to photo # 11 of the June 13^{th} report. The size of the expansion is discussed in the text of this report.

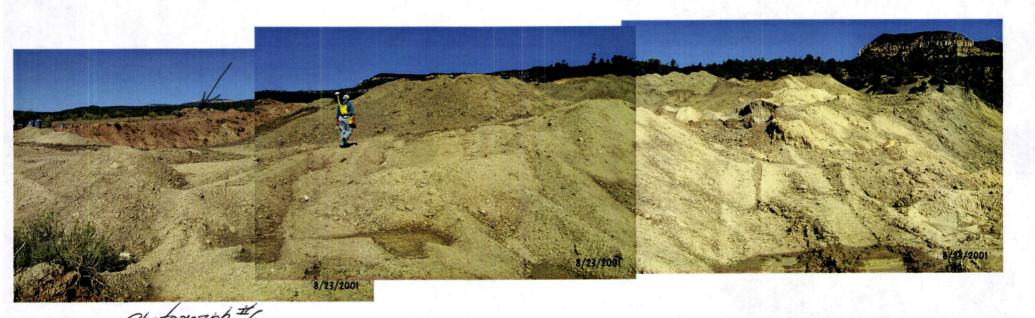
Lease ML 48588, NE¼NW¼, of Section 36, T. 40 N., R. 8 W, Lessee: Robert L. Harris. The lands encompassed by this lease were formerly held under ML 19890 which included all of the E½NW¼ of Section 36. ML 19890 was cancelled for nonpayment of rentals on March 15, 2000. Prior to cancellation of ML19890, and as reported in the June 13, 2000 site inspection report, there were 2.71 acres of un-reclaimed surface disturbance and 1.87 acres of mined land that had been graded and seeded. The recent mining activity, under lease ML 48588, has disturbed approximately 3.37 acres of land, one acre of which overlaps the previous un-reclaimed surface disturbance. Total acres of un-reclaimed mined land, including the active quarry site and the associated overburden dump, is 5.09 acres. See photographs 6 and 7 of this report.

Photograph #6
Looking to the west across surface disturbance created by mining activity on ML 48588. Arrow indicates the location of 2001 quarry site.

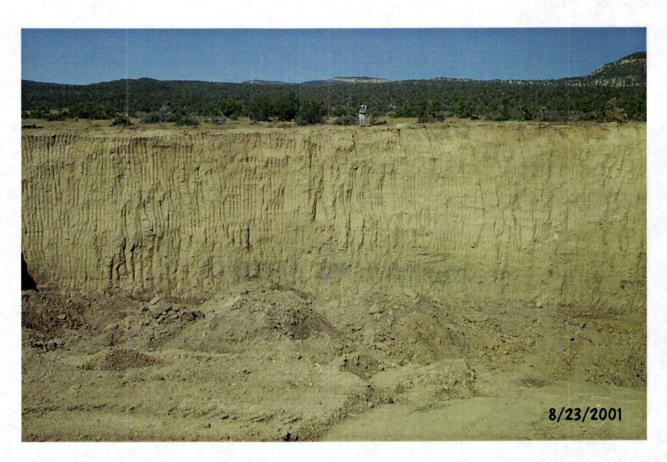
Photograph # 7

Looking west into the 2001 quarry site on lease ML 48588. Using the human figure standing on the top of the pit wall the wall height can be estimated to be approximately 40 to 50 feet high.
